*Compiled by Geoffrey M. Knight*

## Minimally invasive restorative dentistry

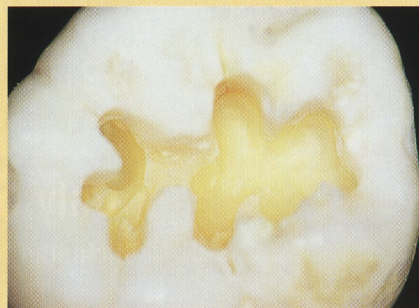
Fig. 1.

Figure 1 shows a minimal intervention cavity prepared using a flat fissure diamond bur. A Diagnodent was used to establish that caries had been removed. After a resin restoration was placed the tooth structure was dissolved away showing the extent of tissue removal required (Fig. 2). Note the flat floored cavity design and the excess amount of healthy tooth structure that was required to prepare this cavity.

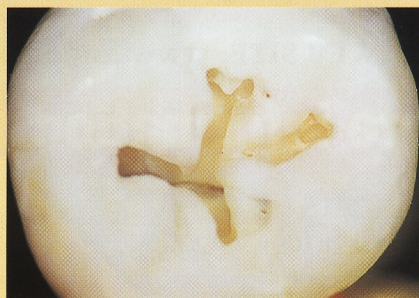
Fig. 3.

When a similar cavity was prepared using a Kreativ Mk5+ air abrasion

unit, cavity preparation was far more conservative after a Diagnodent had confirmed that caries were no longer present (Fig. 3). It is evident after the restoration was placed and the tooth structure removed the conservative and precise nature of caries removal, with minimal interference to healthy surrounding tooth structure (Fig. 4). Note the variation in the extent to which caries had penetrated over the occlusal surface.
